Figure 3 from "Dune Landscape Rejuvenation by Intended Destabilization in the Amsterdam Water Supply Dunes" by S.M. Arens and L.H.W.T. Geelen, pp. 1094–1107. Coppice dunes formed by burial of shrubs (April 2000).

Figure 4 from "Use of Airborne Hyperspectral Data and Laserscan Data to Study Beach Morphodynamics along the Belgian Coast" by Bart Deronde, Rik Houthuys, Walter Debruyne, Dirk Fransae, Vera Van Lancker, and Jean-Pierre Henriët, pp. 1108–1117. Classification image (2000 survey) of the beach between Blankenberge and Zeebrugge from the Spectral Angle Mapper classifications. Eight different sand types could be distinguished (labeled 2–9 in the legend; class 1 is water and class 10 is vegetation).

Figure 3 from "Assessment of Damages from Recreational Activities on Coastal Dunes of the Southern Baltic Sea" by Ralf Grunewald, pp. 1145–1157. Study site 11: dunes within the holiday resort of Karlshagen showing clear signs of heavy disturbance from trampling.

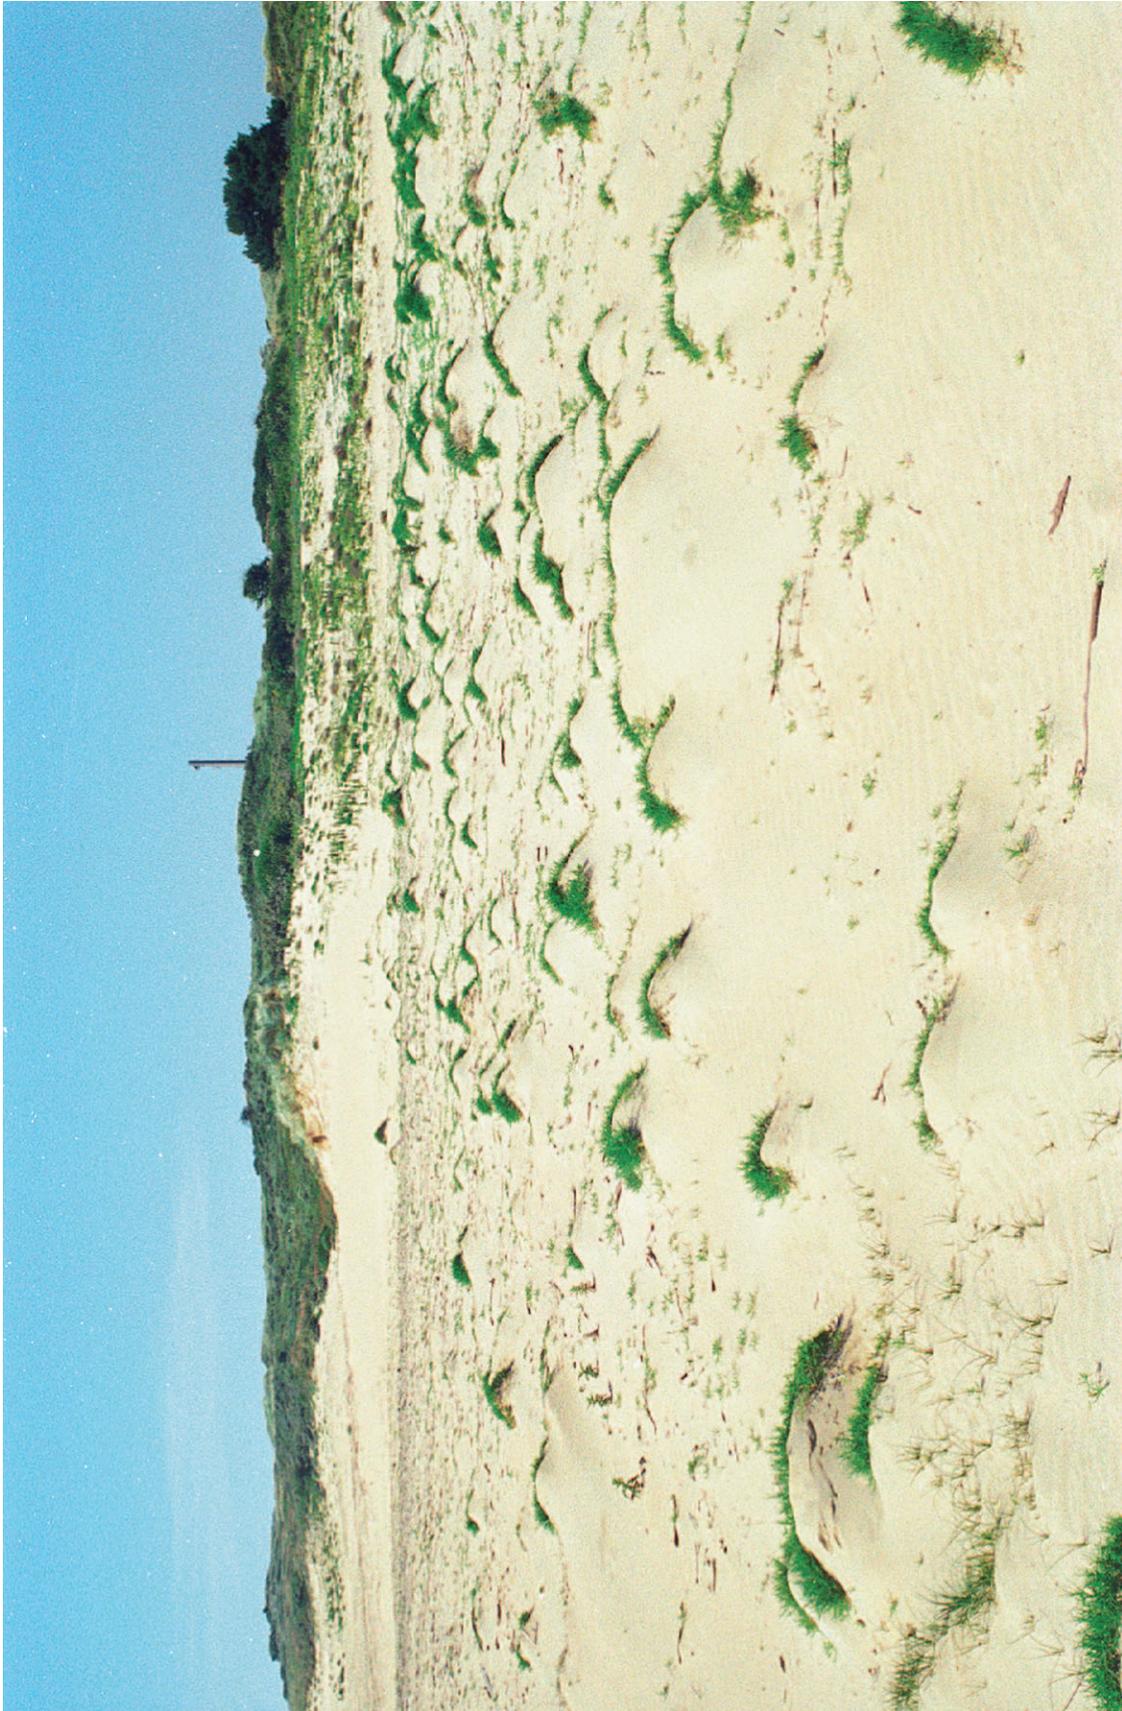
Figure 7 from "Dune Landscape Rejuvenation by Intended Destabilization in the Amsterdam Water Supply Dunes" by S.M. Arens and L.H.W.T. Geelen, pp. 1094–1107. Shadow dunes formed after the establishment of saltwort (*Salsola kali*; July 1999).

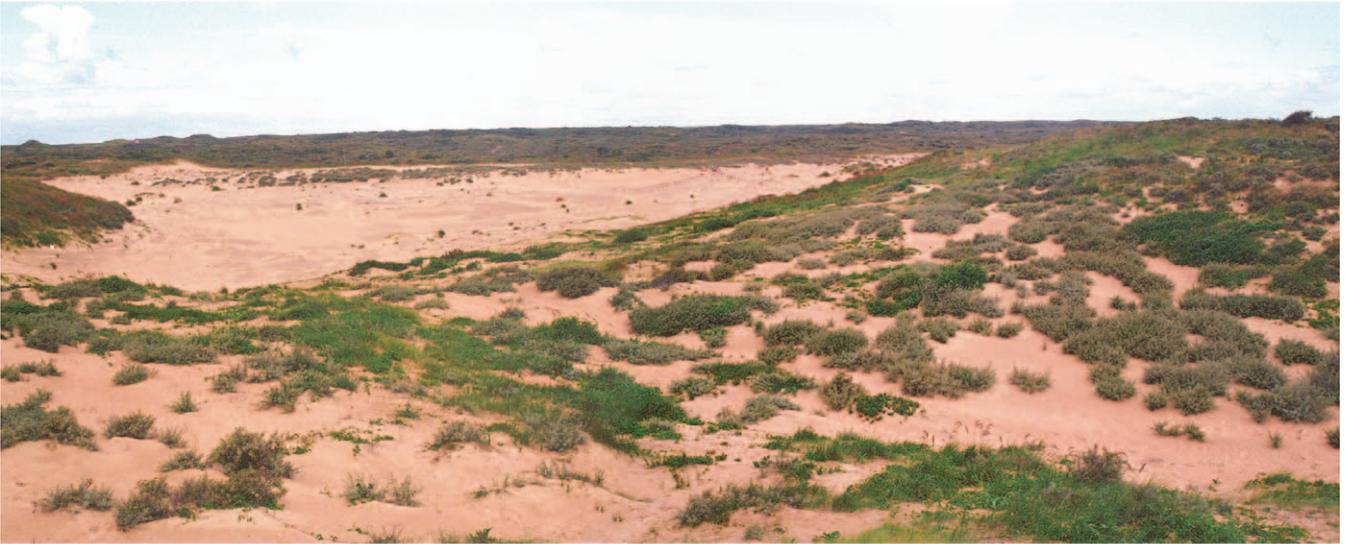
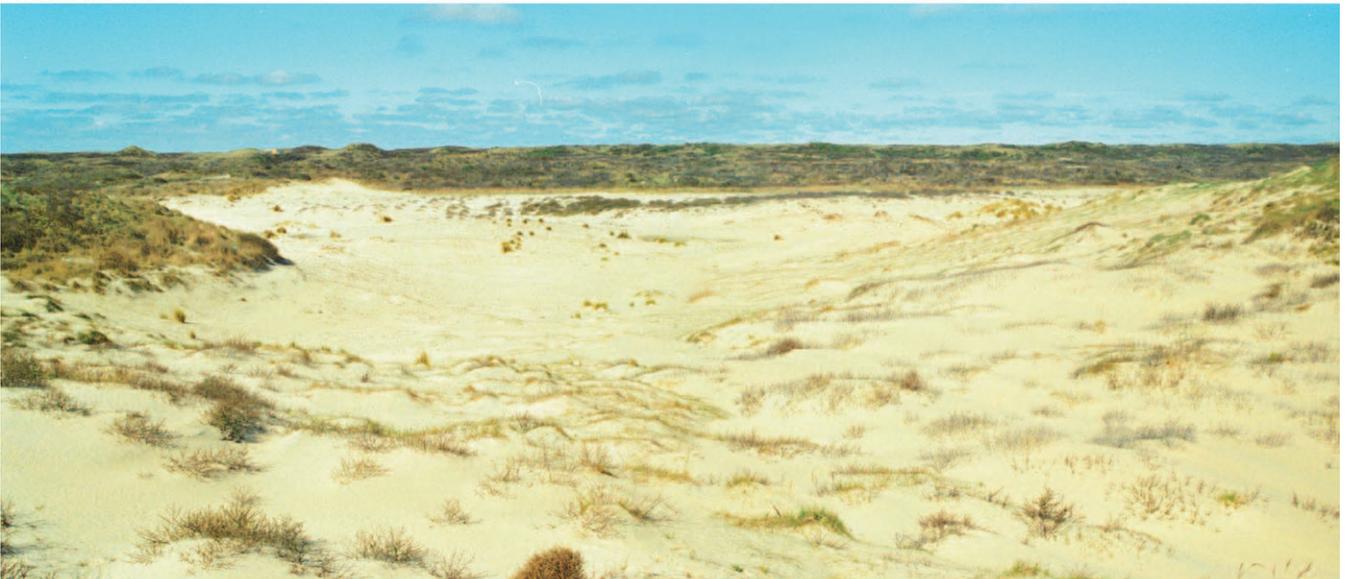
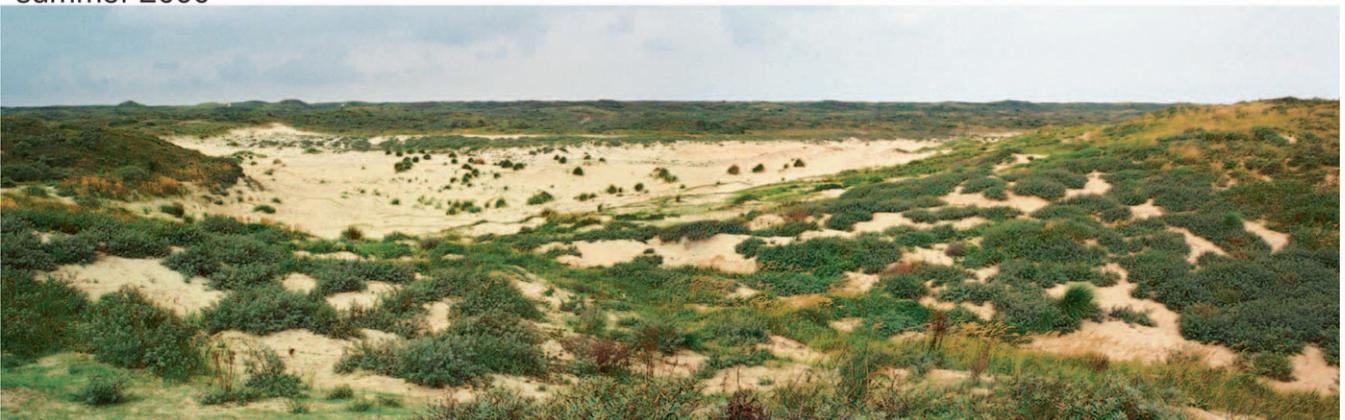
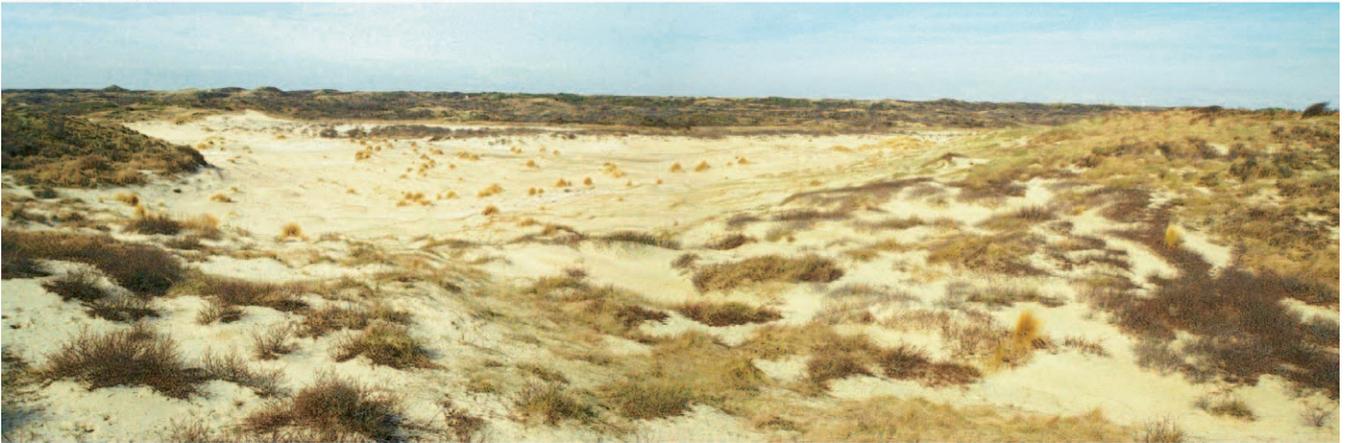
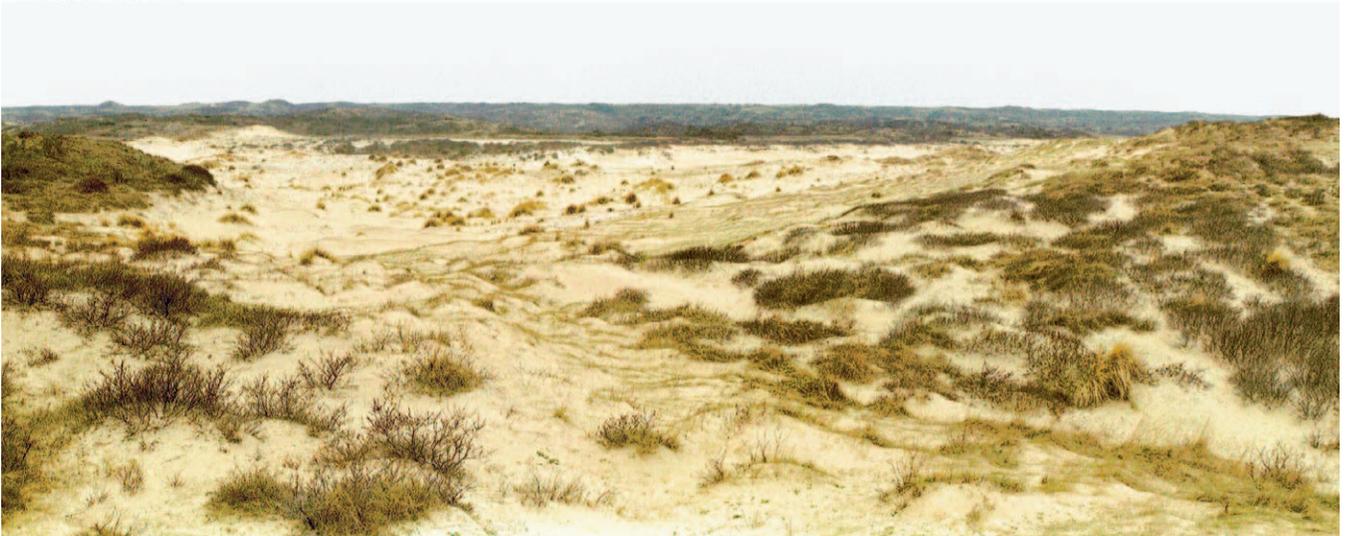
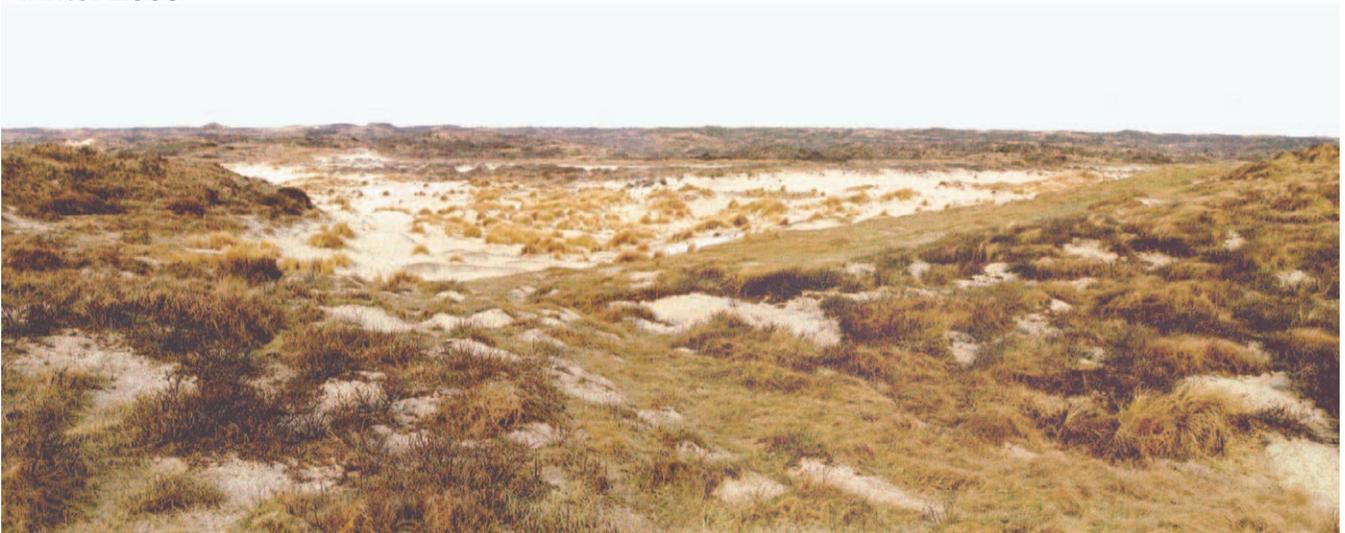
Figure 11 from "Dune Landscape Rejuvenation by Intended Destabilization in the Amsterdam Water Supply Dunes" by S.M. Arens and L.H.W.T. Geelen, pp. 1094–1107. Year-to-year variation in sand burial; from top to bottom: summer 1999; winter and summer 2000; and winters 2001, 2002, and 2003.

Figure 11 from "Dune Landscape Rejuvenation by Intended Destabilization in the Amsterdam Water Supply Dunes" by S.M. Arens and L.H.W.T. Geelen, pp. 1094–1107. Continued.

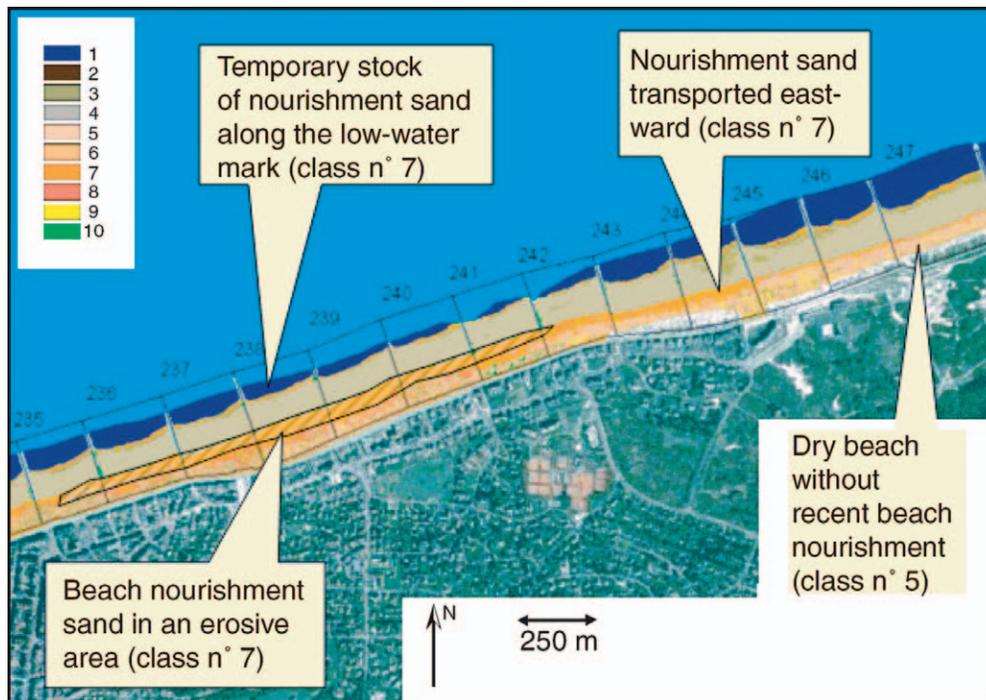
Figure 7 from "Use of Airborne Hyperspectral Data and Laserscan Data to Study Beach Morphodynamics along the Belgian Coast" by Bart Deronde, Rik Houthuys, Walter Debruyne, Dirk Fransae, Vera Van Lancker, and Jean-Pierre Henriët, pp. 1108–1117. Classification image (2001 survey) of the beach near Knokke-Zoute from the Spectral Angle Mapper classifications. Eight different sand types can be distinguished (labeled 2–9 in the legend; class 1 is water and class 10 is vegetation). The numbers ranging from 235 to 247 are beach survey sections.

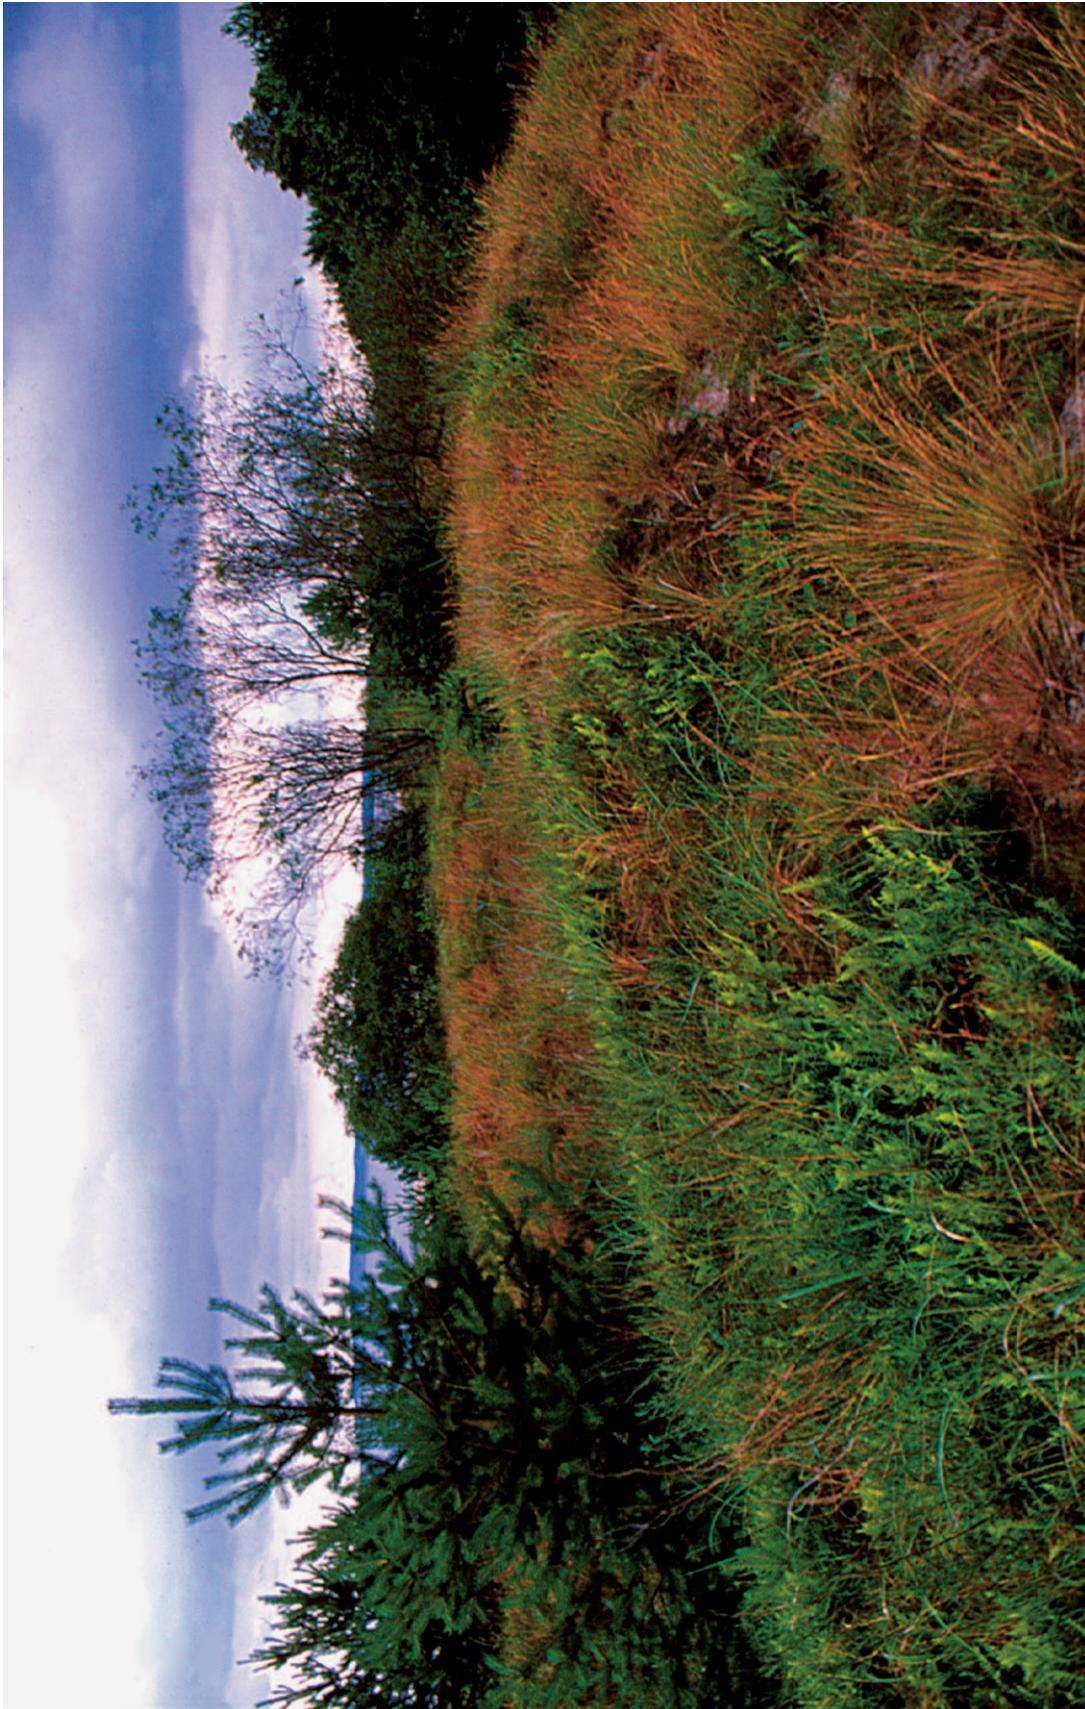
Figure 4 from "Assessment of Damages from Recreational Activities on Coastal Dunes of the Southern Baltic Sea" by Ralf Grunewald, pp. 1145–1157. Study site 1: dunes on Wolin Island showing no major signs of human disturbance.

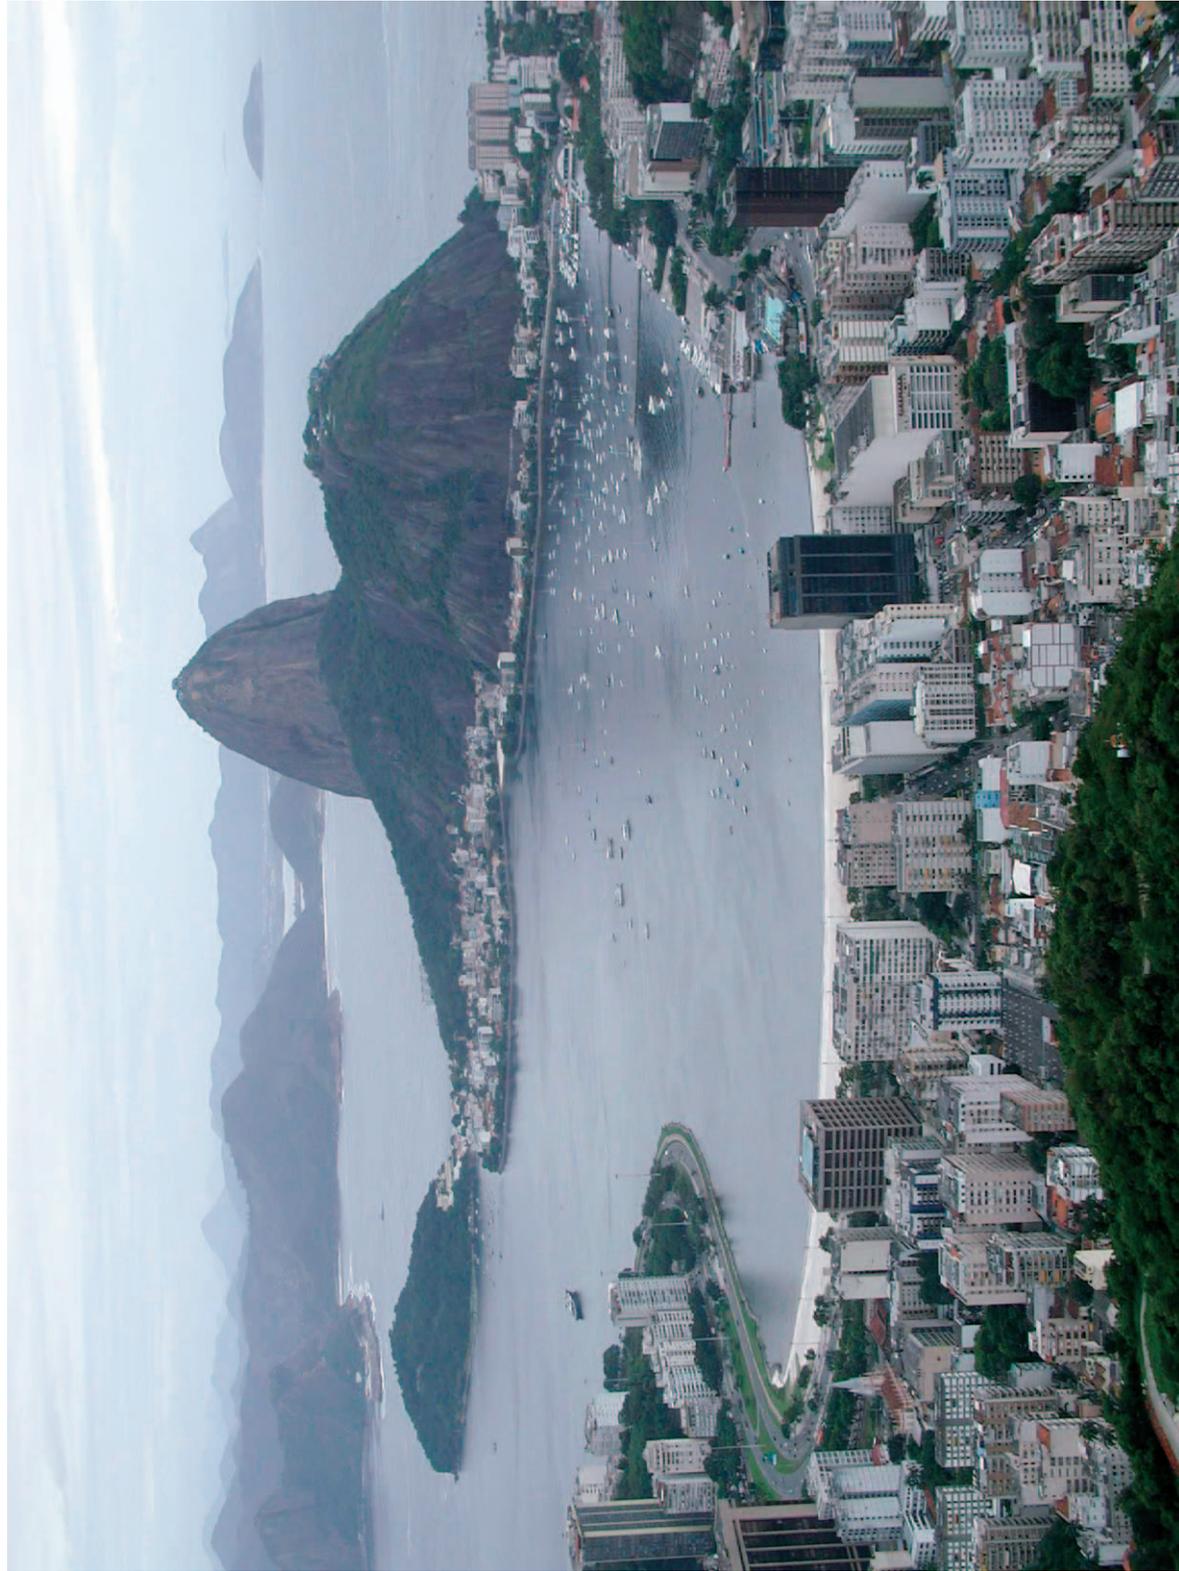
Guanabara Bay and Pão de Açúcar (Sugar Loaf), Rio de Janeiro, RJ, Brazil. These coastal features are relicts of the humid tropical weathering cycle where large corestones are left behind as residuals after the friable regolith is stripped away by surficial processes. Changes in base level (mean sea level) and swings in the climatic regime (wet and dry cycles) produce intense chemical weathering mantles during long stable phases. The pedogenic mantles are eroded during unstable dry climatic phases. Postglacial sea-level rise flooded the coastal valleys and isolated the inselbergs at sea. (Coastal Photograph by Hans Hanson, Department of Water Resources Engineering, Lund University, Sweden.)

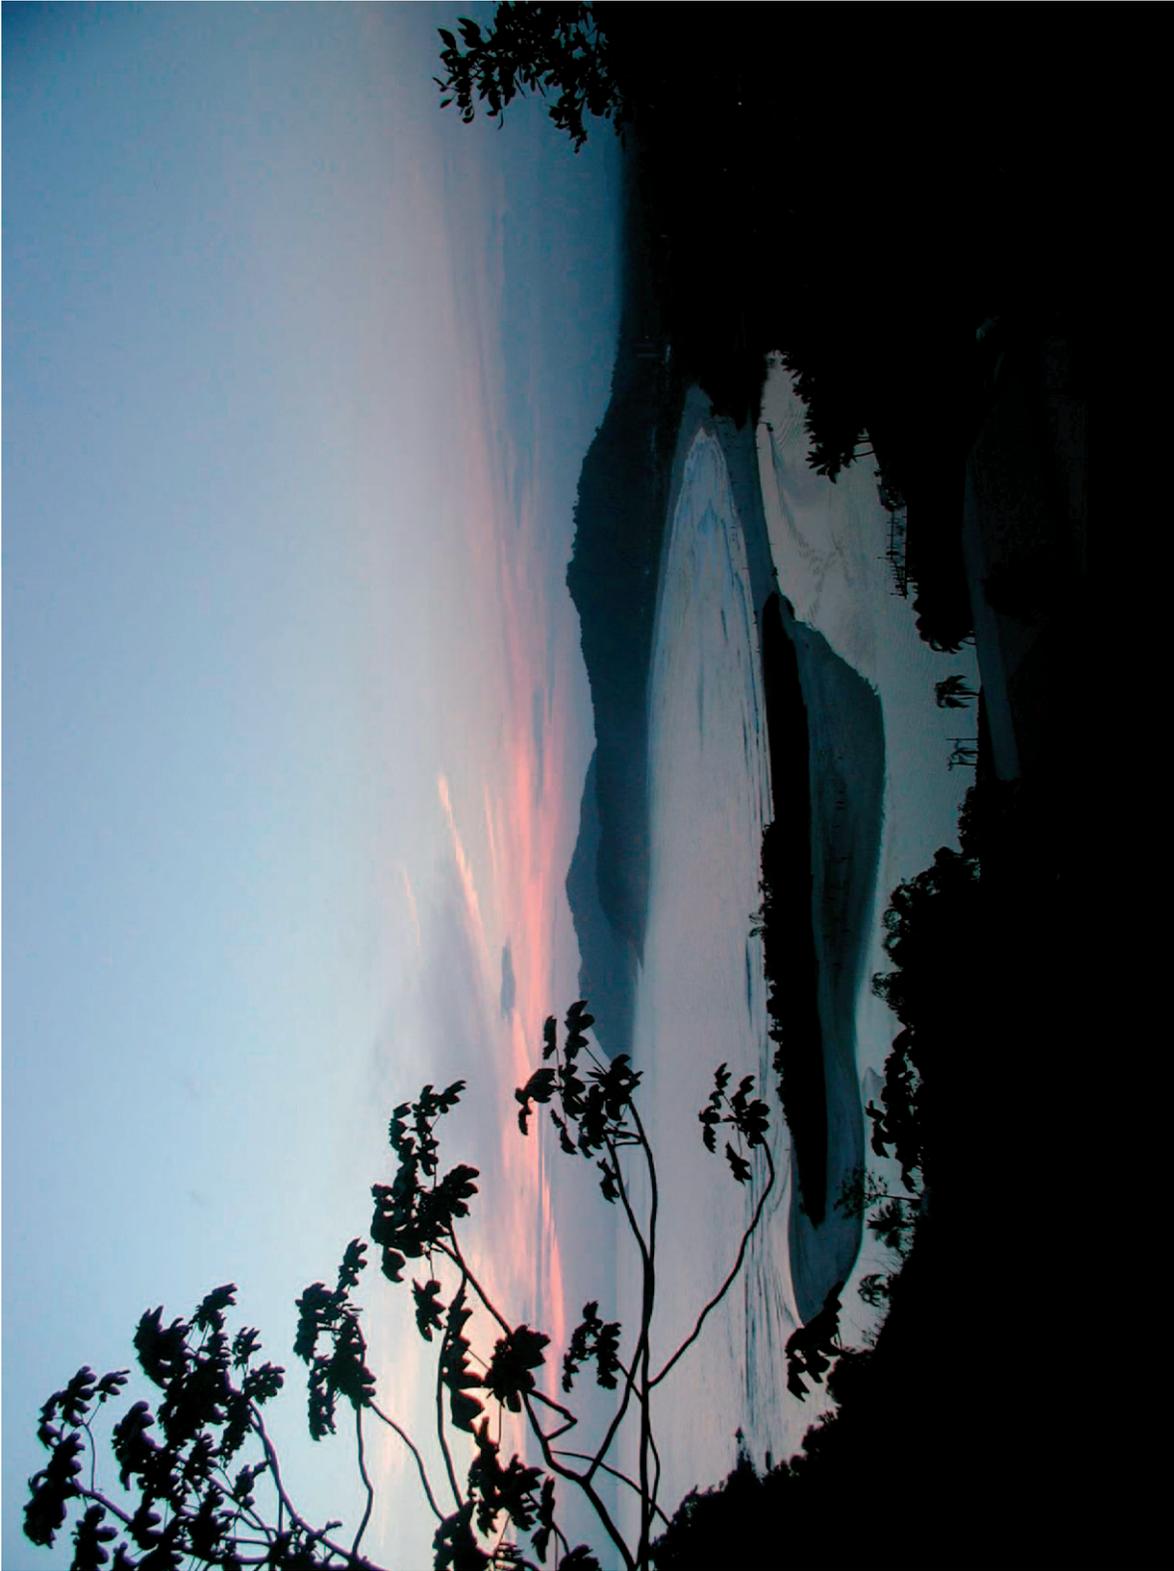
The coast and village of Barra do Una, SP, Brazil. A spit is formed at the mouth of the Una River. This headland bay-beach setting is characterized by large sediment fluxes from the hinterland that feed spit development and naturally renourish the bay beach. The spit (photo foreground) lying downdrift of the inlet, is stabilized by vegetation in its central portion but overwashed farther downdrift (to the right). Similar headland bay beach-inlet geomorphic settings exist throughout the Brazilian southern coast. Usually the migration pathway of the tidal inlets is interrupted by the headland and the inlet location is stabilized adjacent to it. (Coastal Photograph by Hans Hanson, Department of Water Resources Engineering, Lund University, Sweden.)
